CONNECTICUT COASTAL
MERIDEN, CONNECTICUT

**BALDWINS POND DAM
CT 00133**

**PHASE 1 INSPECTION REPORT
NATIONAL DAM INSPECTION PROGRAM**

JULY 1981

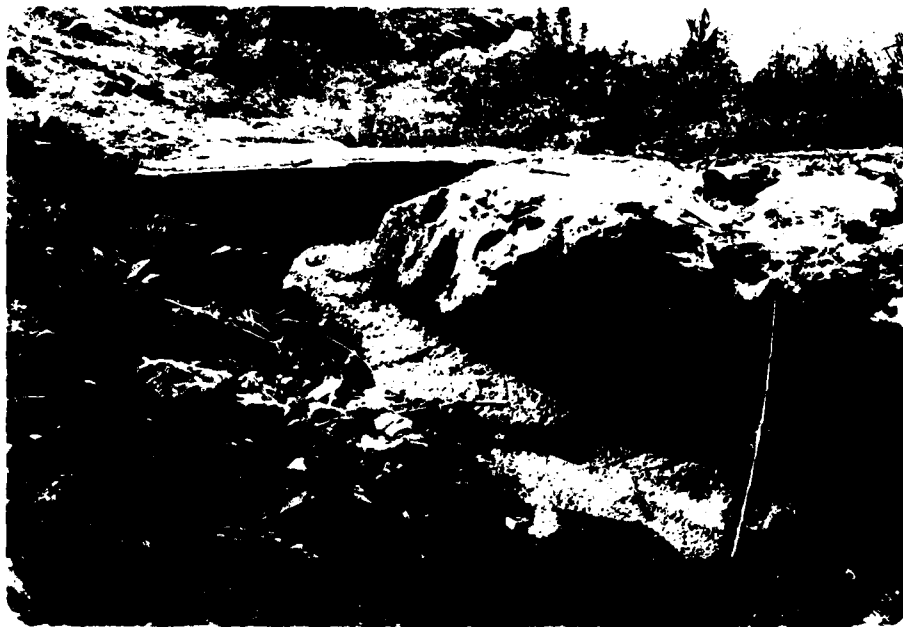
Many seeps were observed along the downstream face, the most notable being four to five locations at the emergency spillway headwall (Sta 0+00 to 0+25). The seepage at this location was exiting from below the downstream riprap and previously placed concrete patch (Photos No. 2 and 3). Flow was also exiting from a gate valve controlled outlet pipe located in the emergency spillway channel (Photo 23). The estimated combined flow in the emergency spillway from all sources at this location was 50 to 100 gallons per minute and appeared clear. Florescin dye was placed in the reservoir on the upstream side of the emergency spillway and after one-half hour no dye was visible exiting from the downstream seeps.

2. Seepage at toe of emergency spillway, flow clear, estimate seepage of 50-100 gallons per minute, total from all sources; rule extended 4 feet. Note outlet control.

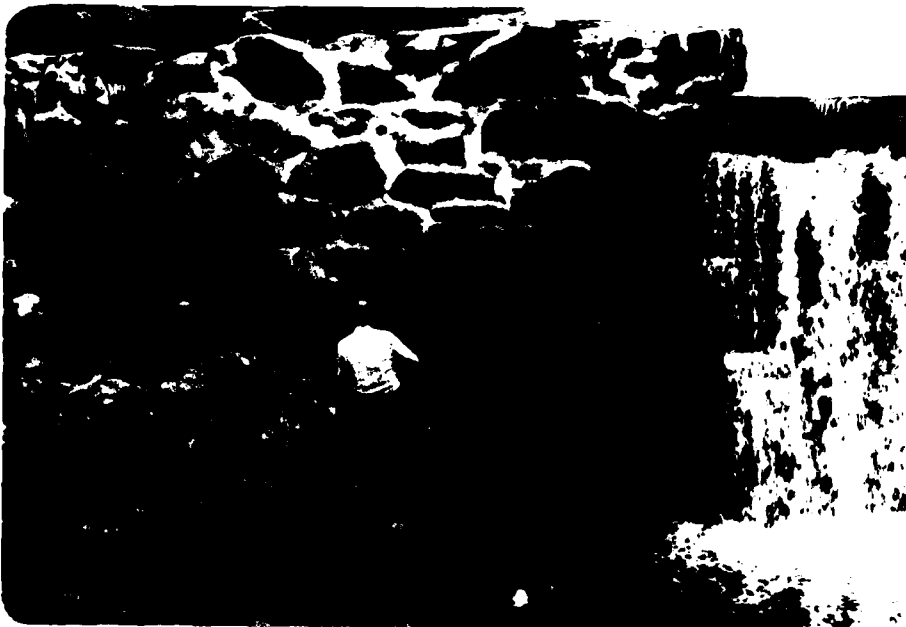
Apparent displacement of the top 8 feet of the downstream masonry wall was observed between about Sta 0+70 to 0+95. The maximum lateral offset was approximately 10 inches and it appears that the masonry joints in this area have been recently remortared (Photos No. 4, 11, and 12).

4. Downstream face of dam to right of spillway, blocks displaced up to 10 inches; seepage below lower block 1-2 gallons per minute. Note stone box outlet.

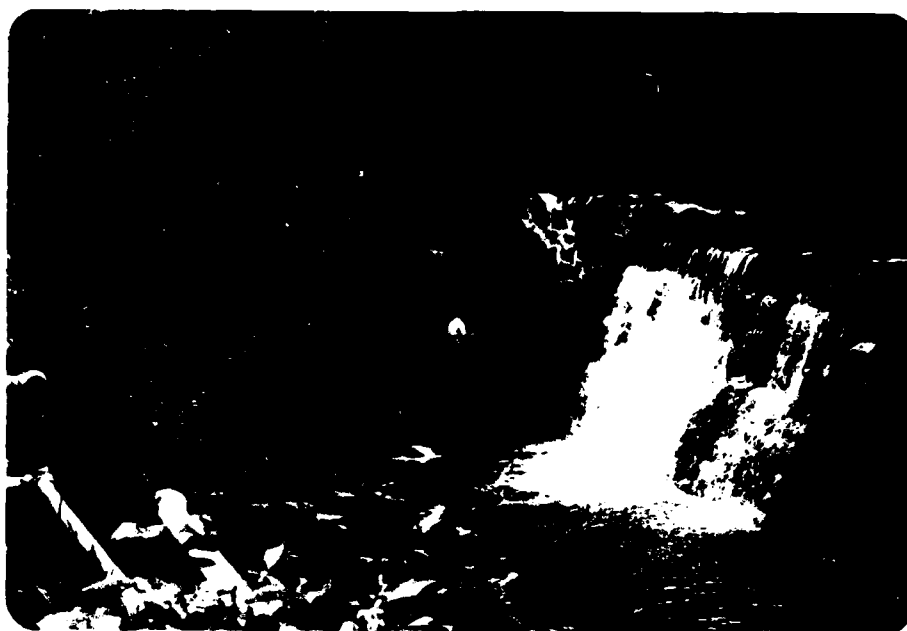
The left half of the dam consists of the stone masonry main spillway (Photos No. 5, & 6). Approximately the left half of the spillway crest was dry and no loose stone blocks were observed. Water was flowing over the remainder of the spillway and, therefore, the condition of the right portion of the spillway was not observed.

5. Spillway and downstream face of dam.

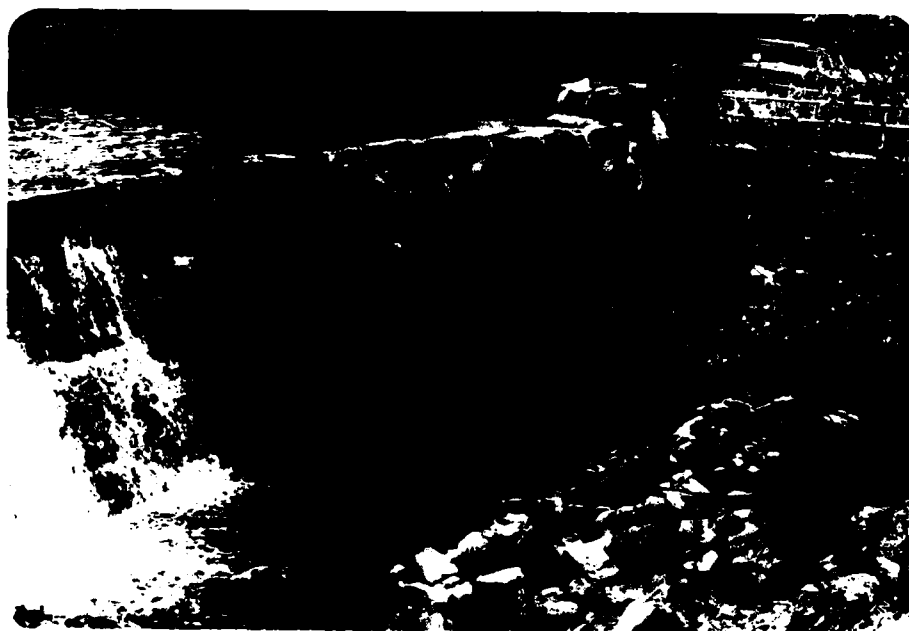
6. View of left side of spillway adjacent to abutment.

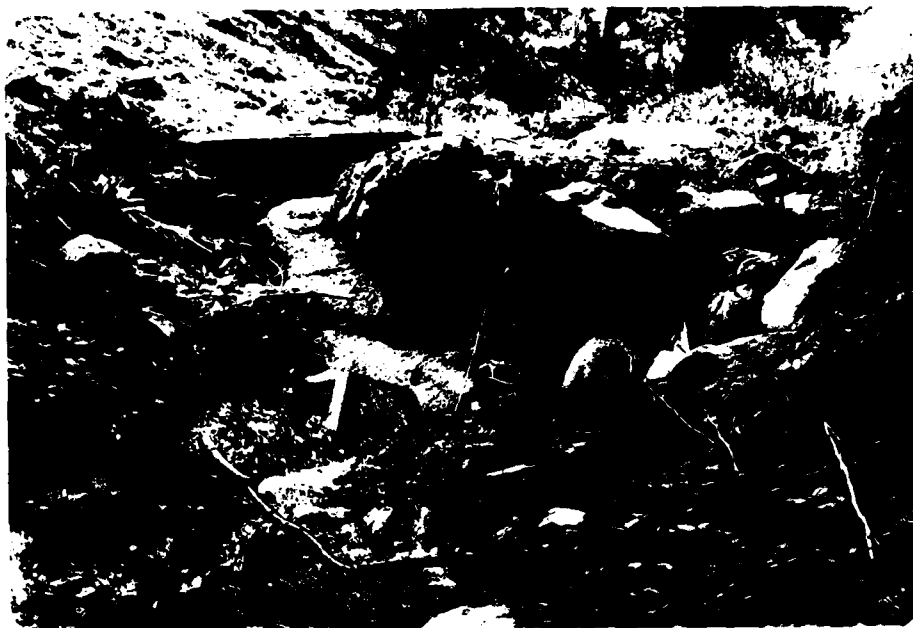
9. View of downstream face of emergency spillway.
